A CASE STUDY OF CONDITION ASSESSMENT OF 210 MW RCC STRUCTURE OF TURBINE-GENERATOR SET IN THERMAL POWER PLANT

*Uday S. Joshi * Rajesh Ranjan*

Central Power Research Institute, Thermal Research Centre, Nagpur,
Email -usjoshi@cpri.in

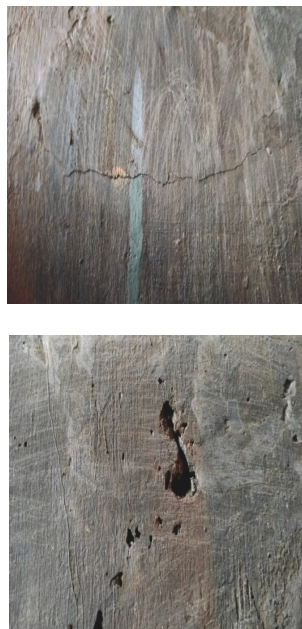
Fig. 4: Cracks & Porosity found in TG deck Pedestal

The present RCC structure identified for structural assessment found to have internal pores, honeycombing and internal cracks and voids in its RCC columns, RCC beams and RCC Bearing pedestals, all of which contribute to unsound hardened concrete. The density of the concrete is increased after the successful implementation of restoration of existing structure. Ultimately , amplitude of vibration was significantly reduced.

High strength microconcrete concrete was used to replace the fractured GP-2 concrete. Low viscosity injection epoxy grouting was done for bearing pedestals. Surface treatment Bearing pedestal surface treatment was done with epoxy mortar.

using high strength epoxy mortar to fill gaps and seal honeycombed patches in RCC columns with injection low viscosity epoxy grouting.

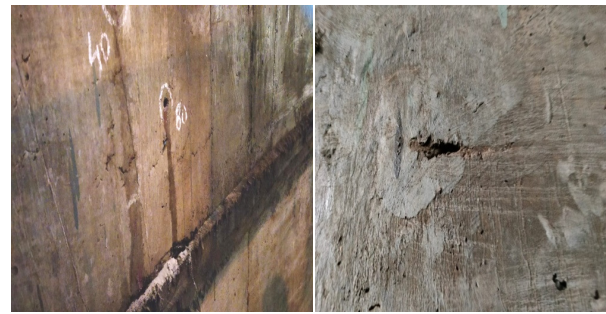
Fig. 5: Honeycombed Concrete observed

Injection low viscosity epoxy grouting in RCC beams & deck slab and sealing of cracks & honeycombed patches with high strength epoxy mortar. Application of epoxy mortar on all sides of beams.

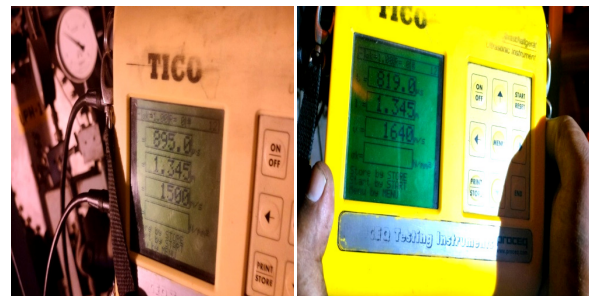
Fig. 6: Ultrasonic Pulse Velocity data

The following observations were made in light of the observed data's correlation with the reference's specifications for hardened concrete. Ultrasonic pulse velocity (USPV) statistics show that the core concrete is of questionable quality, or unsound in nature. Reduced surface strength is indicated by the rebound hammer test.

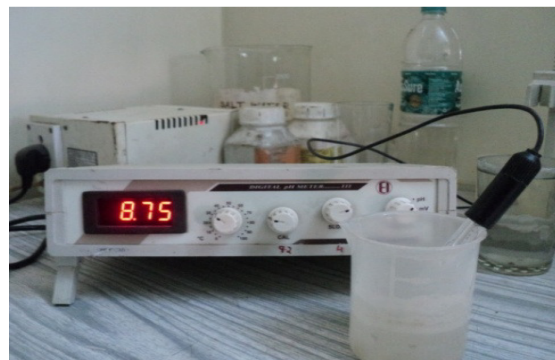
Fig. 8: pH & Potential tests of samples collected

The results of the pH and potential research indicate that the concrete is alkaline both at and beyond the level of the reinforcement.

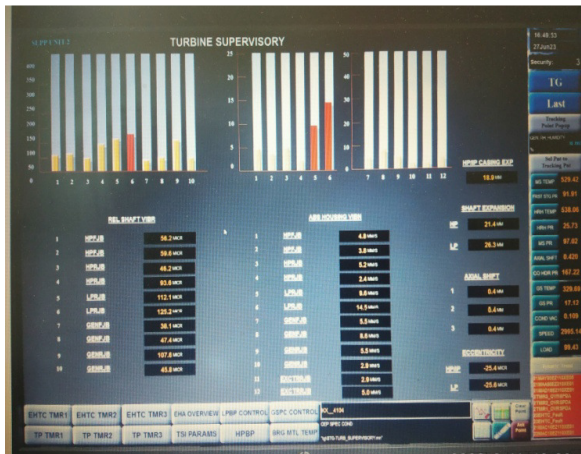
5.6.2 Records from the control room indicate that 14.5mm/s of turbine vibrations were measured before structural assessment and retrofitting.

Figure 10: TG deck Vibration data before restoration

The vibration measurement indicates higher amplitude of vibration observe beyond the limiting value i.e excessive vibrations

The RCC structure of the turbine generator set should be strengthened utilizing new techniques and high-strength materials.

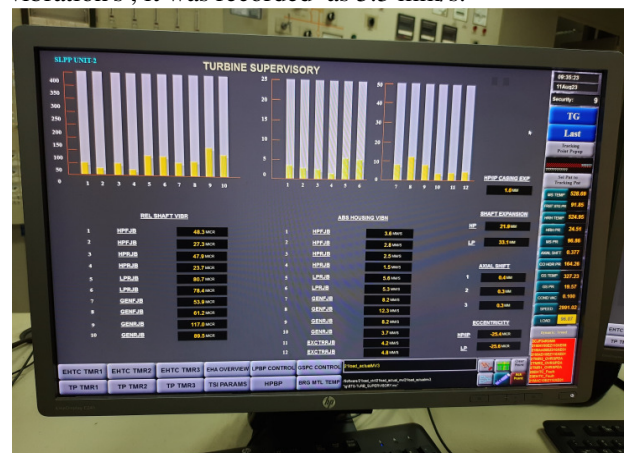
After the RCC Structure underwent post-treatment, the turbine vibrations as determined by control room recordable data significantly decreased. The observation showing a decrease in the amplitude of vibration's , it was recorded as 5.3 mm/s.

Figure 11: TG deck Vibration data after restoration
