Advancing Ship Rudder and Appendage Protection: Glass Flake Epoxy Primers for Cavitation and Corrosion Resistance in Marine Applications.

Dr. Vijesh Vijayan

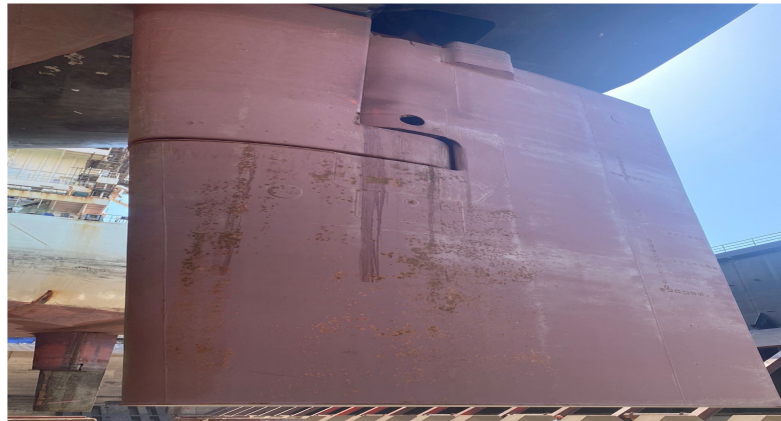
Figure 2 Localized pitting corrosion on the rudder (STBD/PORT) likely resulted from ICCP shutdown during cargo transfer, reducing antifouling effectiveness.

Observation: Vessels with documented ICCP-off operations show 3× higher pitting density on appendages than vessels with uninterrupted ICCP. Cavitation scarring coincides with delamination and underfilm rusting near edges/apertures.

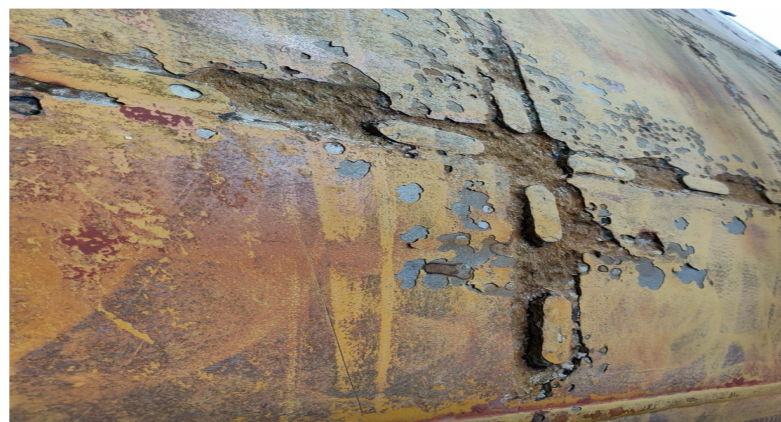
Figure 3 Extensive pitting corrosion and coating delamination on rudder surface.

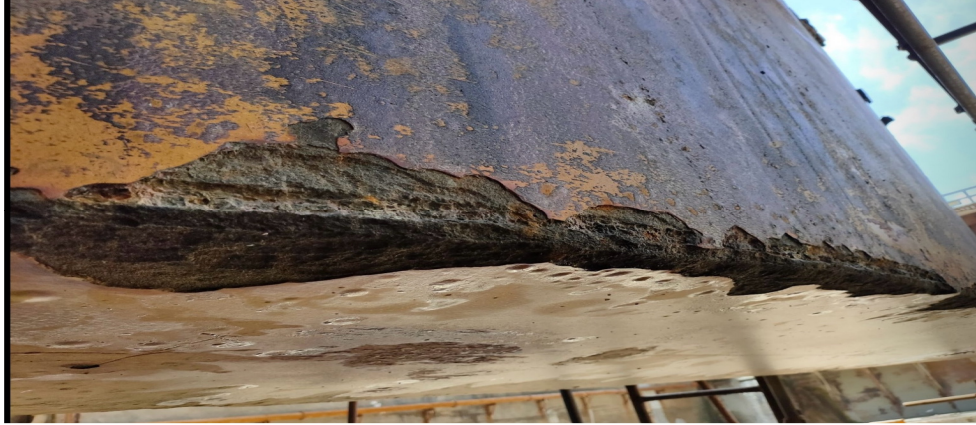
A lower cavitation number indicates a greater likelihood of cavitation inception. This occurs when velocity increases and/or local static pressure decreases conditions commonly observed near rudder leading and trailing edges, horn gaps, and high-curvature transitions, where flow separation and acceleration take place.

Figure 4 – Cavitation erosion at rudder leading edge.

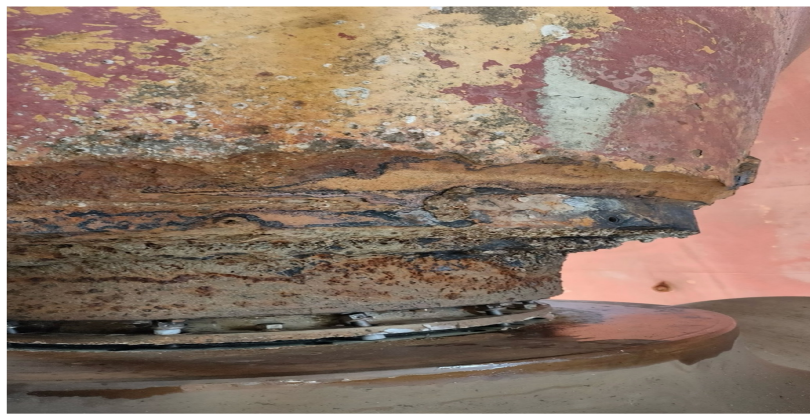
Figure 5 – Microbial corrosion and surface degradation on rudder gear mount.

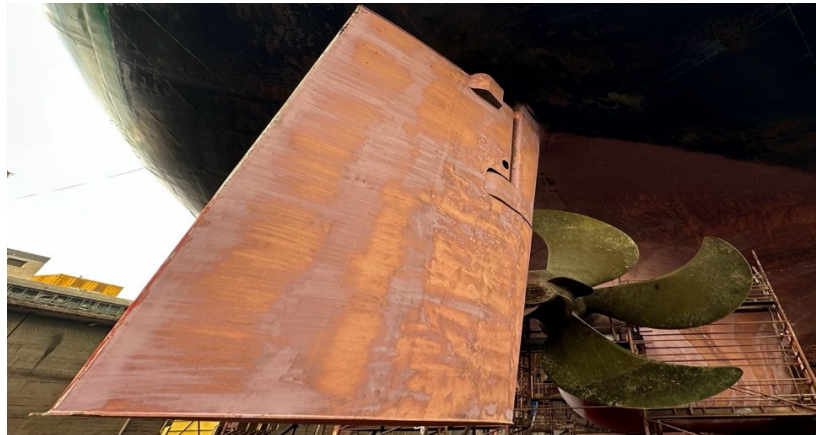
Figure 7 – The LNG carrier rudder and associated assemblies were coated with a glass flake epoxy system, followed by an antifouling coating. The photograph shows the condition of the coating system upon arrival in drydock after 60 months of service. The inspection confirms that the coating remains in good condition, with no visible signs of localized pitting corrosion, cavitation erosion or coating delamination on rudder surface.
