Abutment Failure and Rehabilitation of Multi-span Simply-supported Bridges: Baghipol Bridge Case Study

Baghipol Bridge is located in west part of Afghanistan in Farah Province. Due to high traffic and seasonal floods, one of its abutments was failed by the active earth pressure. The abutment structure was made by sheet piles. This type of abutment can be very cost efficient and time saving for the construction; however, in the case of high traffic flow and heavy axle loading considerable bending and deflection in sheet piles can be observed, which can cause significant damage in superstructure. This paper studies the causes for this failure in the bridge abutment by analysis of the Finite element models, and describes the rehabilitation strategy to maintain the traffic flow during the construction of new abutment.

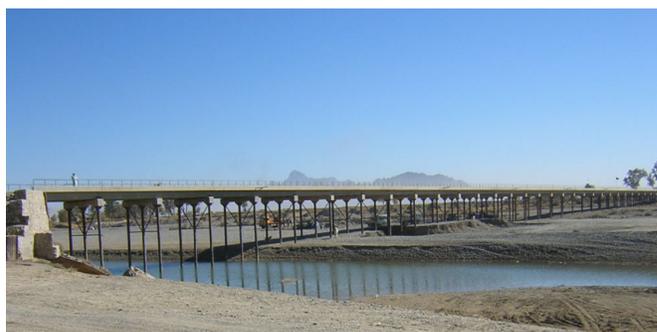
Fig. 1 Baghipol Bridge

Baghipolbridge was built by the United states of America about 60 years ago on Farahrod river in Farah province of Afghanistan. This bridge is one of the most important transportation structures in west of Afghanistan. It is a gateway for major parts of west areas to Afghanistan ring road.

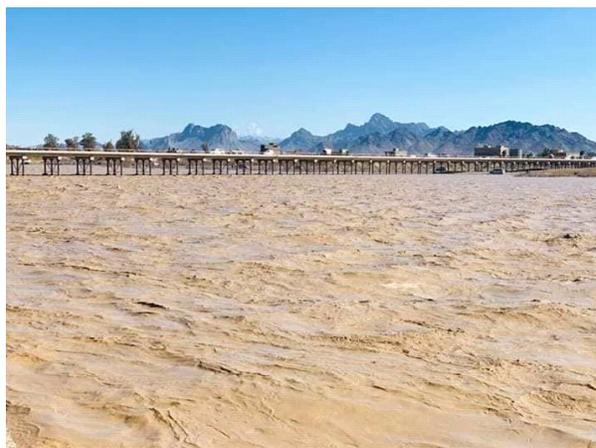
Site observations show that there was an excavation done by local contractors along the damaged abutment, which may provide access of water to the bridge abutment.

Fig. 4Baghipol Bridge during Seasonal Floods.

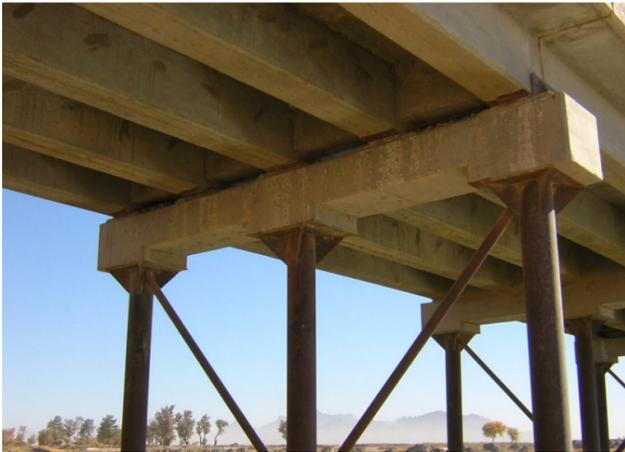
Baghipol Bridge is a multi-span simply supported bridge with reinforced concrete superstructure and steel pillar system. Bridge abutment system is made by sheet piles and stone wing walls. The dimensions of the bridge are presented in figure 6.

Fig. 5 Bridge pillar and support system.

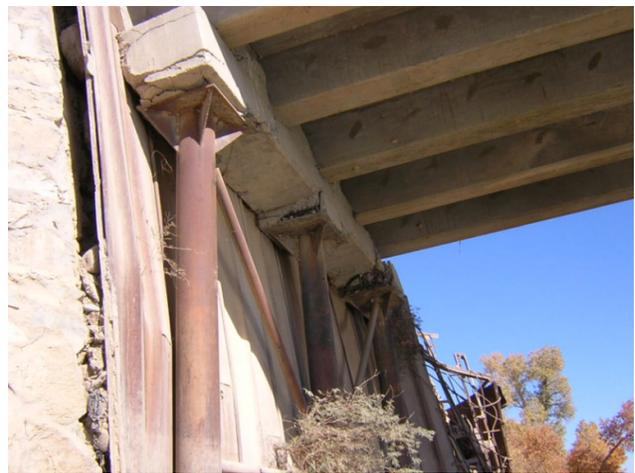
- Damages occurred in the downstream side of the abutment.
- Abutment sheet pile was bent with the maximum displacements in the higher parts of the sheet pile.
- Pier cap near the abutment was fractured with exposing the reinforcements.
- Piers near abutment had lateral displacement caused by bending of the shell plates.

Fig. 7 Shows the damages in the abutment

In this project one of the main concerns was that at least one lane should be available for daily traffic passage. So the rehabilitation was suggested to be done in the two phases. In each phase the half side of the abutment was installed and the other side was available for daily traffic.

1. Preparing the temporary pier foundation;
2. Traffic management in one lane;
3. Installation of temporary pier and beam;
4. Temporary sheet pile driving in the middle line of approach along the road;
5. Remove the one side of the back filling soil and construction of the sheet pile sheet strengthening structure (Bars and concrete Blocks)
6. Demolition the damaged pier cap;
7. Construction of the new pier cap;
8. Construction of the approach slab;
9. Change the traffic to the other side and continue the above procedure for the second half abutment.
