A CASE STUDY OF CONDITION ASSESSMENT OF 210 MW RCC STRUCTURE OF TURBINE-GENERATOR SET IN THERMAL POWER PLANT

*Uday S. Joshi * Rajesh Ranjan*

Central Power Research Institute, Thermal Research Centre, Nagpur,
Email -usjoshi@cpri.in

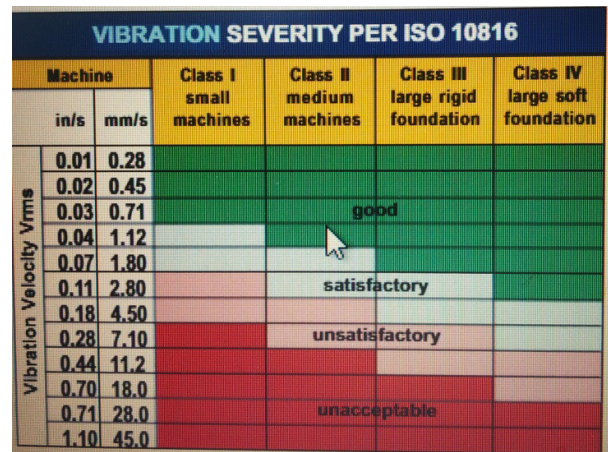
Figure 9: Vibration severity chart

5.6.2 Records from the control room indicate that 14.5mm/s of turbine vibrations were measured before structural assessment and retrofitting.
